416 SERVICE INFORMATION

Type(s): 6121, 6126, 6700, 6701, 6702, 6703, 6704, 6705

SUBJECT: CHECK PAWL, SPRING, STUD AND TAB KEYLEVER — REDESIGNED

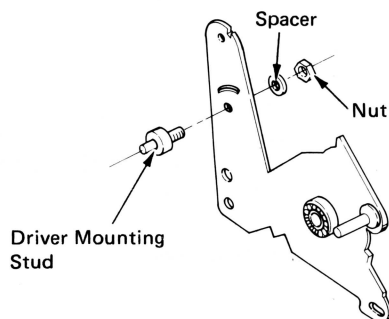
Figure 1

Backspace failures due to a broken driver mounting stud may be corrected using the backspace driver mounting stud B/M.

1. Remove driver mounting stud from backplate by tapping lightly.
2. Remove the "C" clip, washer, driver, pitch cam (disconnect pitch cable), and pitch cam spring from the stud.
3. Insert the new stud (24-155) in the pitch cam spring, pitch cam (connect pitch cable) and driver.
4. Install washer and "C" clip on the front of the stud.
5. Install stud through the hole in the backplate and secure with washer and nut (Figure 1).

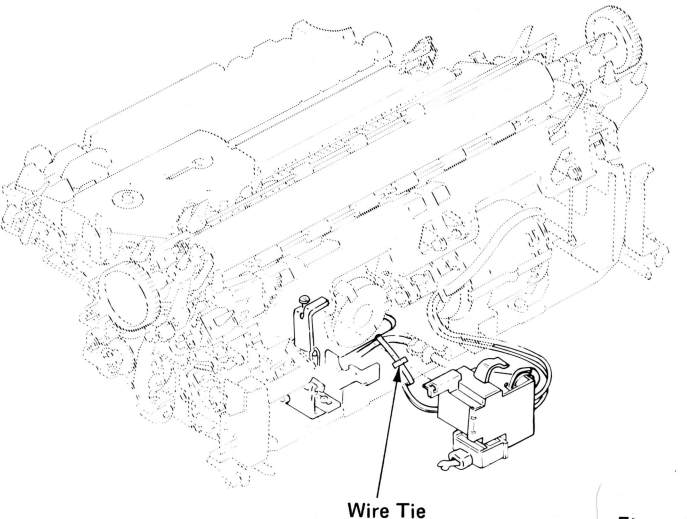
PURPOSE:
PRECAUTION: The motor shell could become live (i.e., line voltage present on the motor shell) on dual pitch "Selectric" IIIs manufactured prior to the S/Ns listed below. The length of the line cord from the white strain relief to the transformer may be excessive. The added length can allow the cord to contact the motor pulley/shaft. This may wear the line cord insulation, resulting in the shell becoming live.

1. Unplug the line cord and remove the covers.
2. Check for damage to the line cord insulation in the area indicated and replace it if damage is evident.
3. Install wire tie (11-606) as shown in Figure 1.
4. Reapply power and check for proper machine operation.

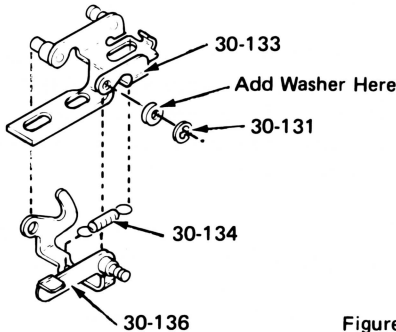
Figure 1

If experiencing problems in lifting the top cover (30-151) on sound machines, check for excessive side-to-side motion of the hood latch on the RH hood bracket (30-133). The top cover latch (30-136) may have slipped off the RH side of the bracket (30-133) and jammed the cover. Washer (P/N 1091220) has been used in the plant to eliminate the problem and can be used if needed in the field. Install washer as shown in Figure 1.

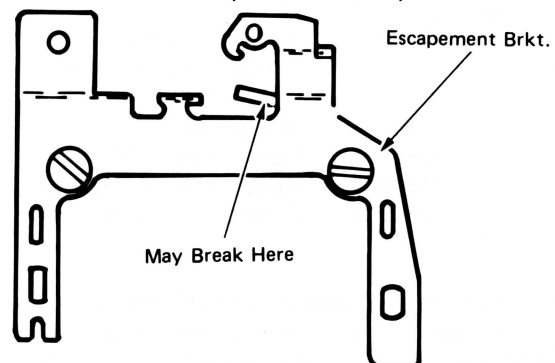
Figure 1

Some machines within the specified S/N range were manufactured with improperly heat treated escapement brackets (07-1).

If this condition occurs replace the escapement bracket.

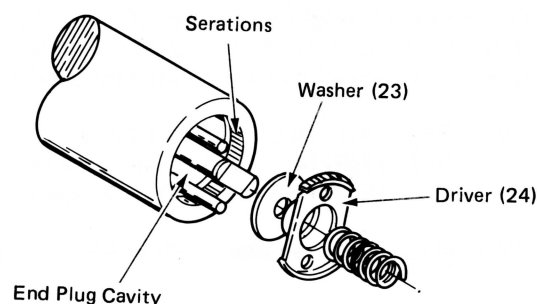
Figure 1

Some machines were manufactured with the potential of preventing the platen driver from fully engaging the platen. This may be caused by either an interference between the cavity in the platen end plug and the washer (12-23) — fig. 1, or small pieces of plastic end plug material that may become lodged between the driver (12-24) and the end plug serrations. If experiencing this condition, clean out the platen end plug and replace the existing washer with the current smaller diameter washer PN1359915.

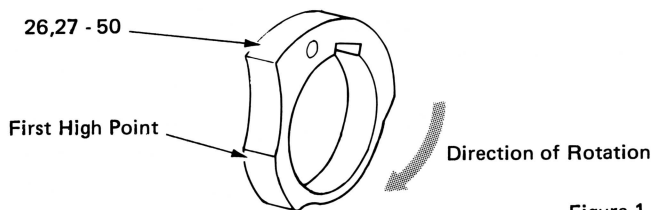
Figure 1

Some machines were manufactured with a defective correction tape feed cam (26, 27 -50) which is slightly undersized on the first high point. This condition can be observed by slowly hand cycling the correction mechanism while checking the amount of correction tape feed. The tape should feed one-third before print and two-thirds after print. Machines failing to pull enough tape during the initial feed operation will have random correction failures.

Defective correction feed cams can be replaced without removing the ribbon plate assembly by using steps 1 thru 9 (exclude step 2) of the print sleeve removal procedure in the Service Manual.

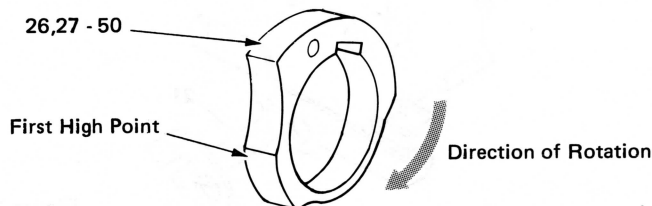
Figure 1

Some machines were manufactured with a defective correction tape feed cam (26, 17-50) which is slightly undersized on the first high point. This condition can be observed by slowly hand cycling the correction mechanism while checking the amount of correction tape feed. The tape should feed one-third before print and two-thirds after print. Machines failing to pull enough tape during the initial feed operation will have random correction failures.

Defective correction feed cams can be replaced without removing the ribbon plate assembly.

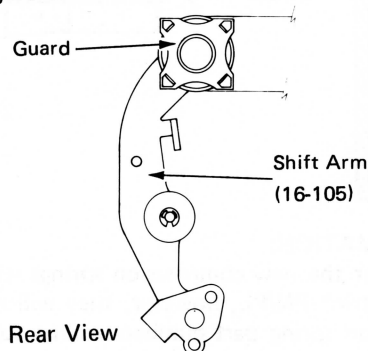
Figure 1

NOTE: Due to a tolerance build-up of the related parts (shift pulley, rotate tape and velocity guard), a binding condition may occur on some machines. Reducing the length of the velocity guard tips by sanding, filing, etc., will reduce the binding condition.

To reduce repeated rotate tape replacement caused by the tape becoming disengaged from the shift arm pulley, the Mag Card velocity tape guard (25-34; P/N 1457036). may be installed. Prior to installing the guard, ensure that a machine malfunction is not causing the tape problem. Install the guard as shown in figure 1.

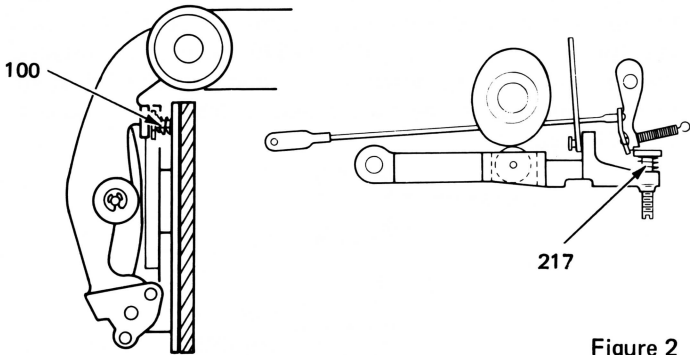
Figure 2

A limited number of machines have reached the field with compression springs that may allow the stop screw(s) to move. If experiencing problems with varying selection adjustments, install the appropriate lock nut (16-100) or (23-217) to correct this condition.

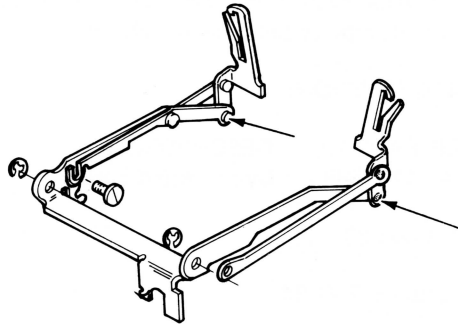
Figure 1

A number of machines were manufactured with defective fabric ribbon lift guide (13-37) rivets (Fig. 1). The rivet hardness and assembly method were changed to reduce breakage. If experiencing ribbon lift failures, check for either a loose or broken rivet and replace the lift guide assembly as necessary.

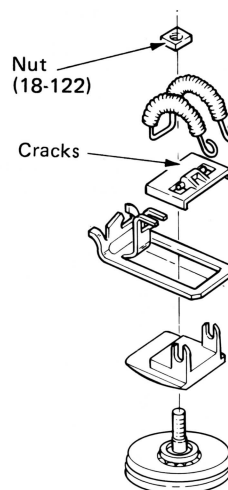
Figure 1

On the next service call check for cracks in the area indicated (Fig. 1). Also, examine the nut for two peen marks in the area of the pulley stud threads which are necessary to keep the nut tight. Replace the transport bracket assembly if cracks are found or the peen marks are missing.
